Use Attainability Analysis
for
WBID 1006 Tributary to Perche Creek

Submitted by
SES, Inc.

To
Missouri Department of Natural Resources
Water Protection Program

Field Data Sheets for Recreation Use Stream Surveys
Data Sheet A - Water Body Identification
(For water body being surveyed)

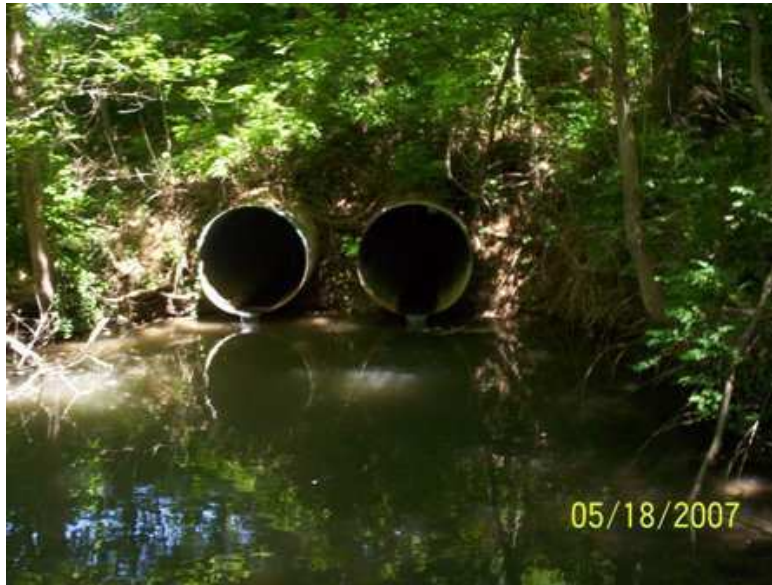
Site# 1 Photo ID# 105, Upstream

WBID # 1006 **Site #** 1
Mark # 48 **Dissolved Oxygen (ppm)** 9.7
Upstream Views Physical Dimensions: Is there any water present at this view? yes

If so, is there an obvious current? no

none

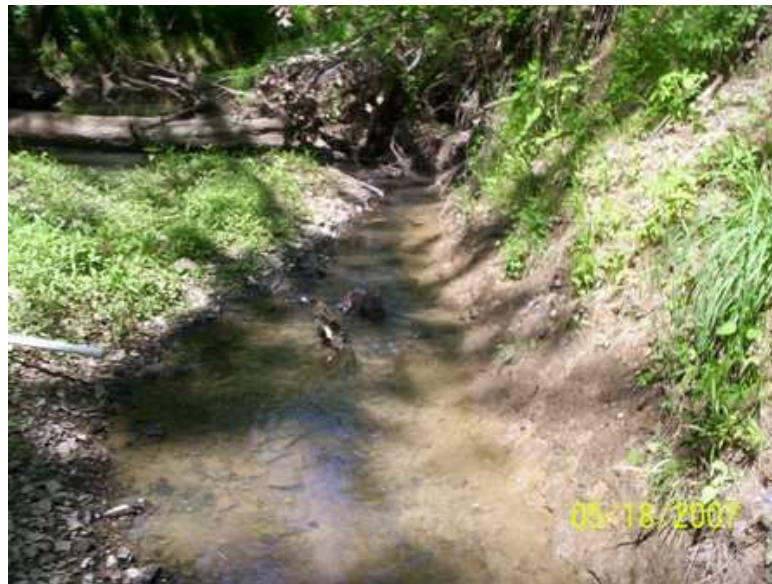
Site# 2 Photo ID# 107, Upstream

WBID # 1006 **Site #** 2
Mark # 49 **Dissolved Oxygen (ppm)** 10.5
Upstream Views Physical Dimensions: Is there any water present at this view? yes
 If so, is there an obvious current? no

none

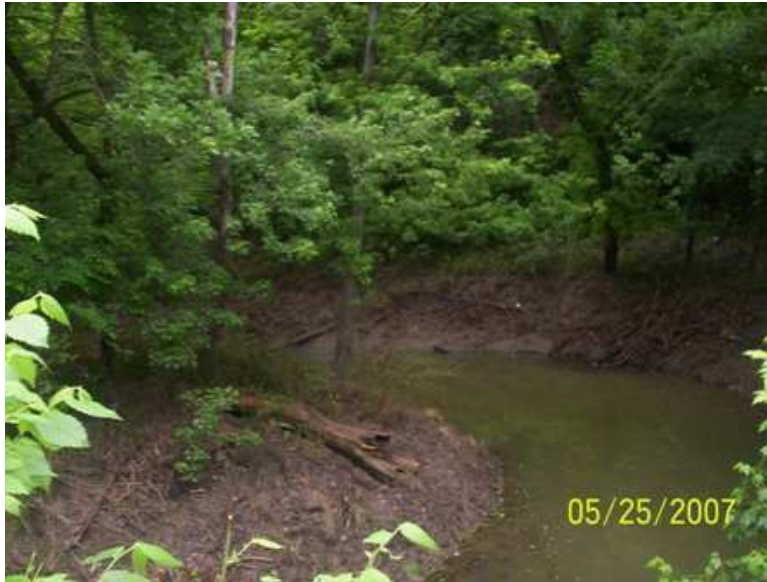
Site# 3 Photo ID# 54, Upstream

not base flow, flooded

not base flow
